## Inventory & Check In Report

48 Townmead Road  
London  
Fulham  
SW6 2RR

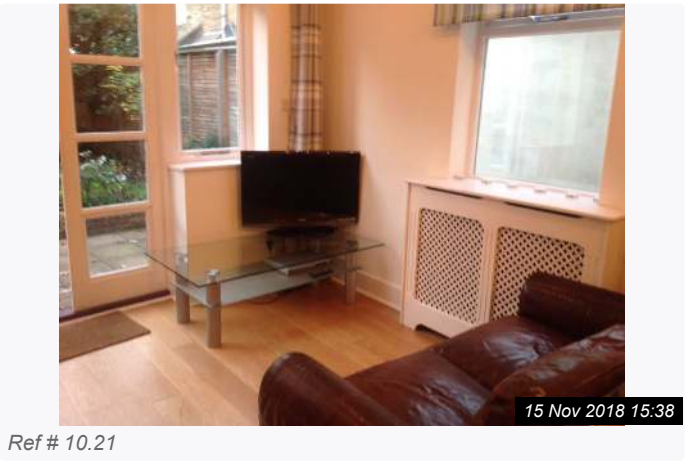
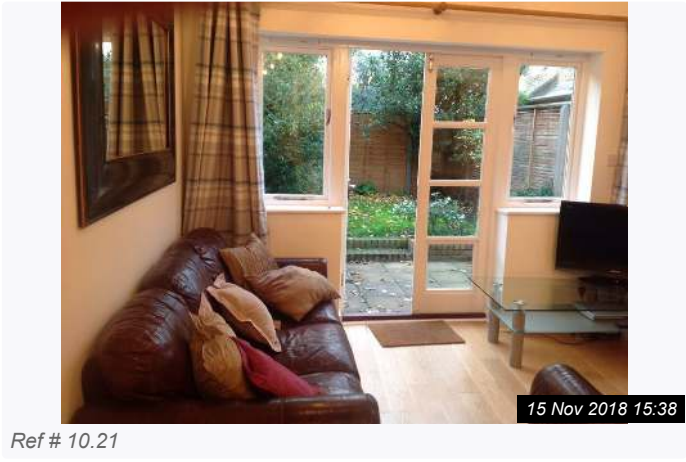
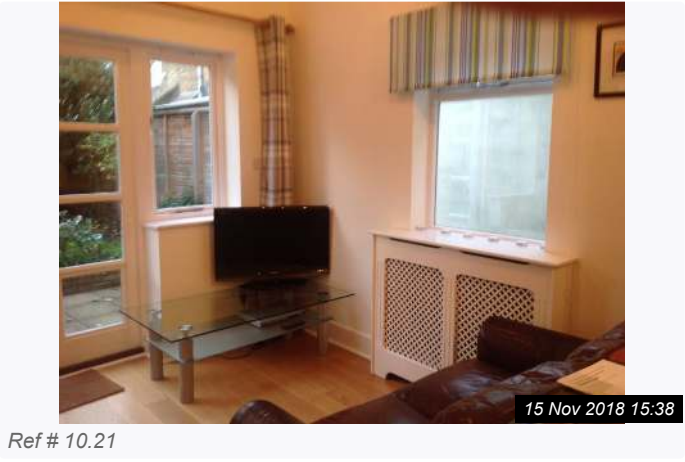
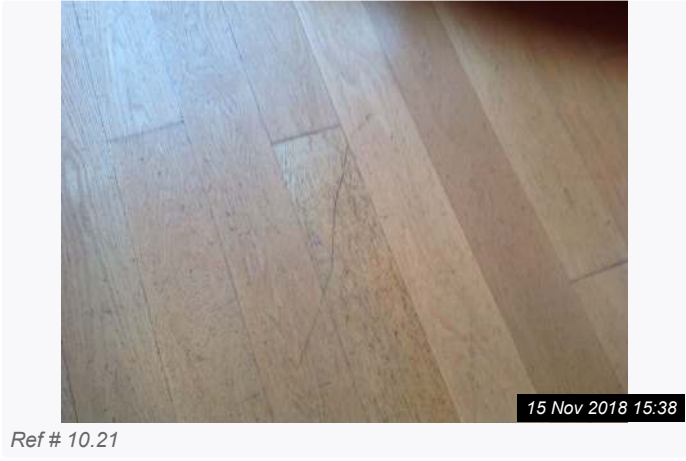
10. Open Plan Reception Room (Cont.)

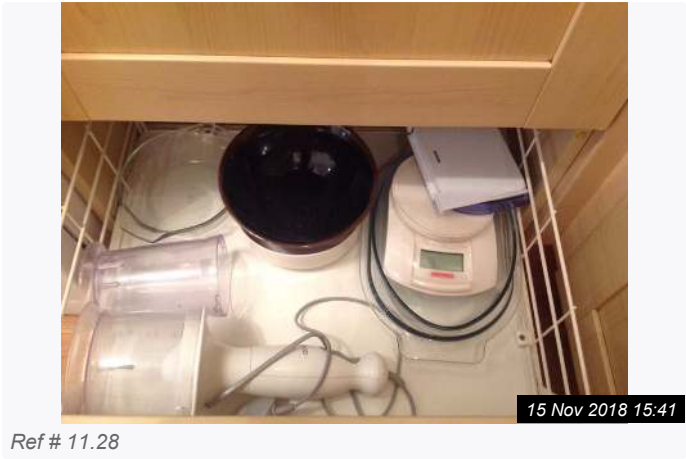
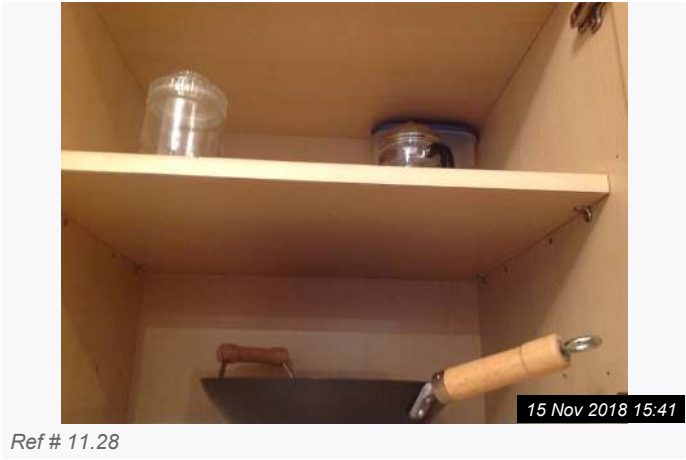
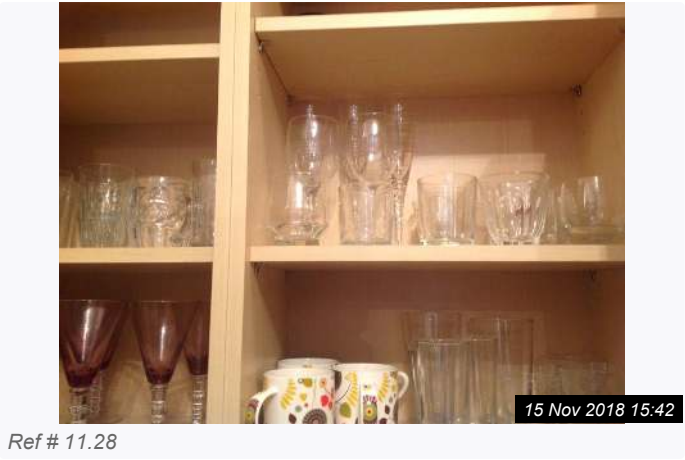
## 12. Kitchen Appliances

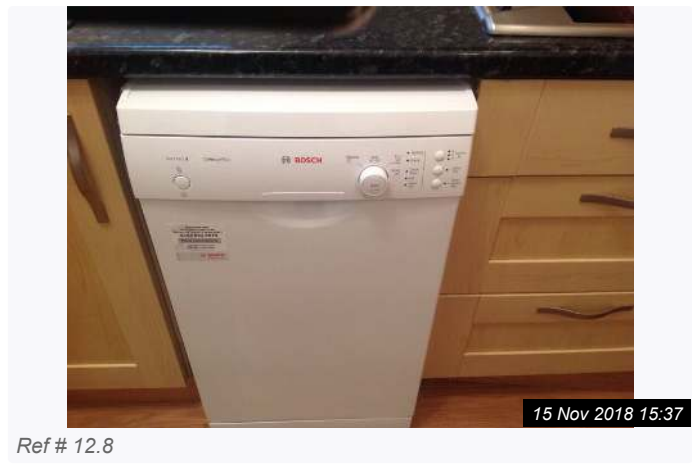
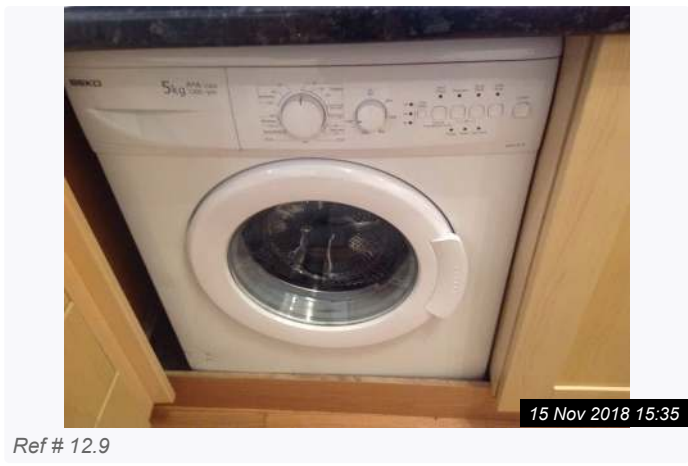
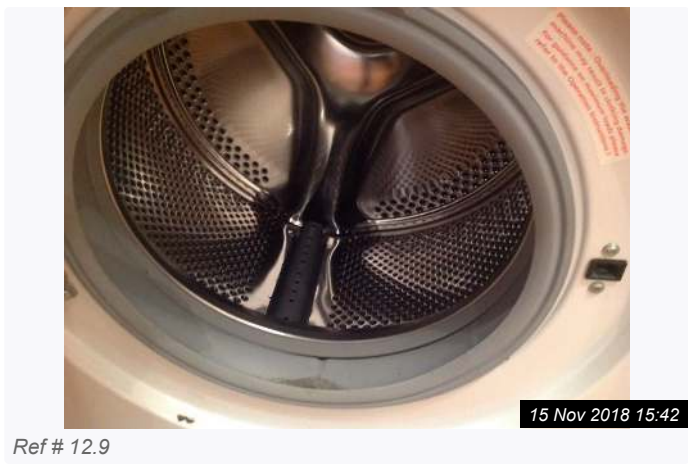
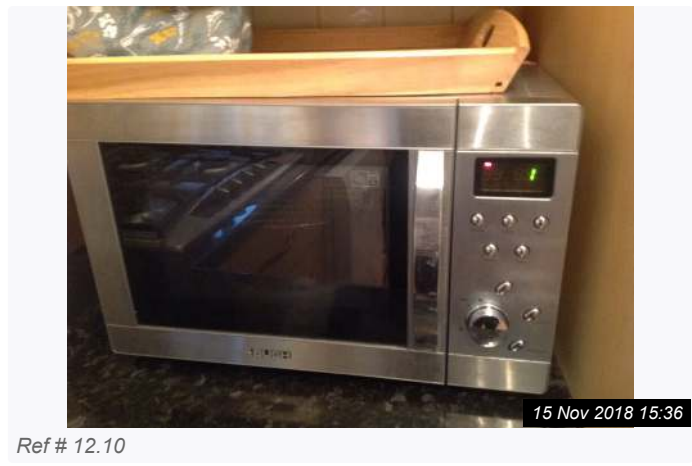
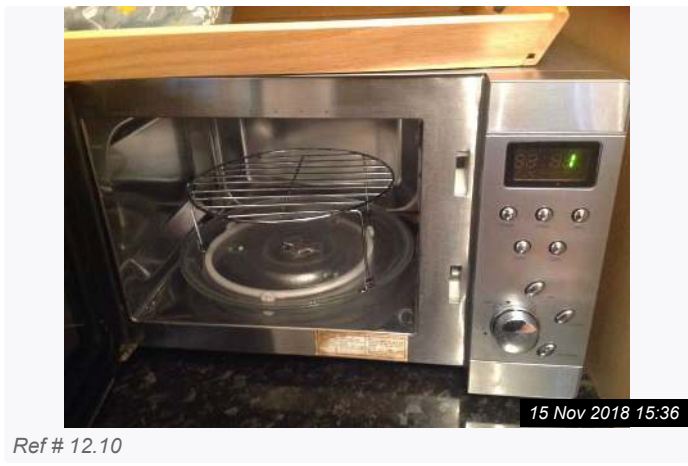
12. Kitchen Appliances (Cont.)

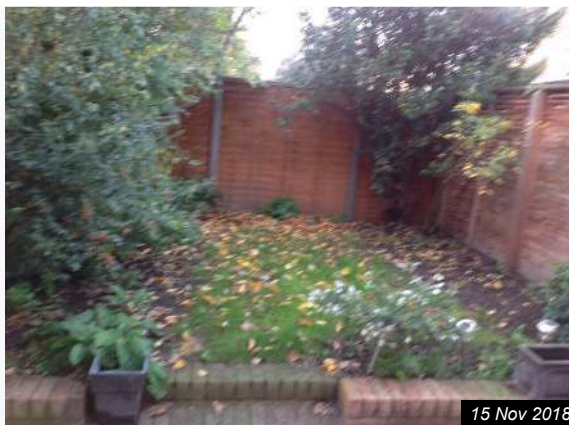
| Item | Description | Condition | Tenant Comments |
|---|---|---|---|
| 13.5 Threshold | Wooden | worn | |
